Skagafjörður Heritage Museum Booklet no. XVI

Traditional Building Methods

Sigríður Sigurðardóttir

2012

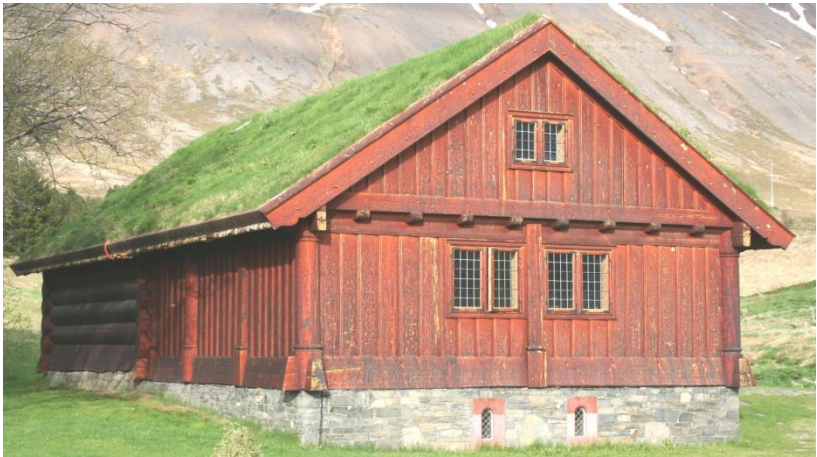
Auðunarstofa (Auðunn's House) at Hólar is a reconstruction of a 14th-century building of Norwegian type. The building stands on a basement of cut stone, which is bonded with mortar. The near end of the building as seen in the photo is of stave construction, while the farther end is a log structure, an entirely different method. Both types of building were common in the middle ages. The roof is turfed. Photo Jóhann Zoëga.

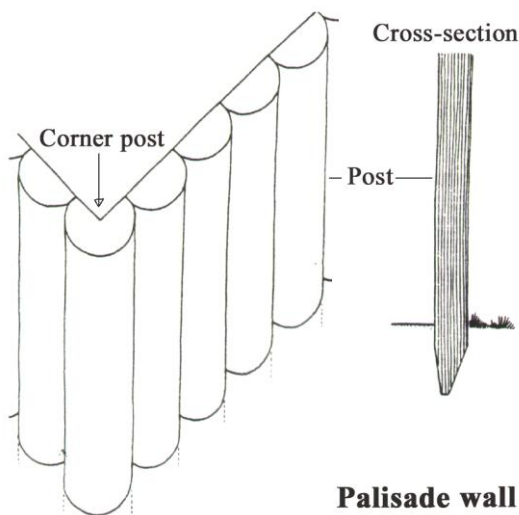
Figure: Håkon Christie, Middelalderen bygger i tre, p. 13.

Stave buildings may be broadly divided into three categories, by age and method. One was the *stólpapil* or palisade wall. In this case the wall

comprised half-logs, tongued-and-grooved together (*sporað*), with the ends embedded in the ground, or thrust down into gravel. Wall-plates fitted over the top of the wall, and were notched (*læst*) together at the corners. This construction method was known throughout Europe at the time when Iceland was settled.

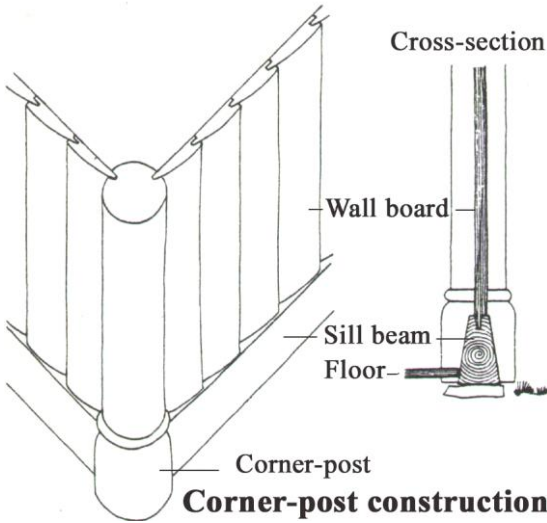
Figure: Håkon Christie, *Middeladeren bygger i tre*, p. 14.

The second stage of stave construction became common in the ninth to eleventh centuries throughout northern Europe. This is the corner-post building (*horn-stólpahús*), which rested on corner-posts embedded in the ground. Sill beams (*aurstokkur*)² were fixed by mortise-and-tenon into the corner-posts, and planks were slotted vertically between them. The holes dug for the corner-posts were filled with rocks. If the sill-beams did not stand free of the ground, they were protected from damp by placing stone or rocks below them (*púkkað undir*). A wall-plate was slotted on top of the corner-post and wall, fixing the structure together. The wall has the same

appearance inside and out. This method produces a far sturdier structure than the palisade method. Corner-post buildings were common in north-west Europe in the 12th century. In windy regions, many buildings of this type were protected by exterior walls or berms of turf, for weatherproofing and insulation. In the third type of stave construction, the corner-posts are

no longer embedded in the ground, but stand on foundation stones, and stones are laid underneath the sill beams. It is highly likely that such buildings were protected with walls and roof of turf. It was also advisable to anchor them firmly to the ground with stays (*stag*) for greater stability.

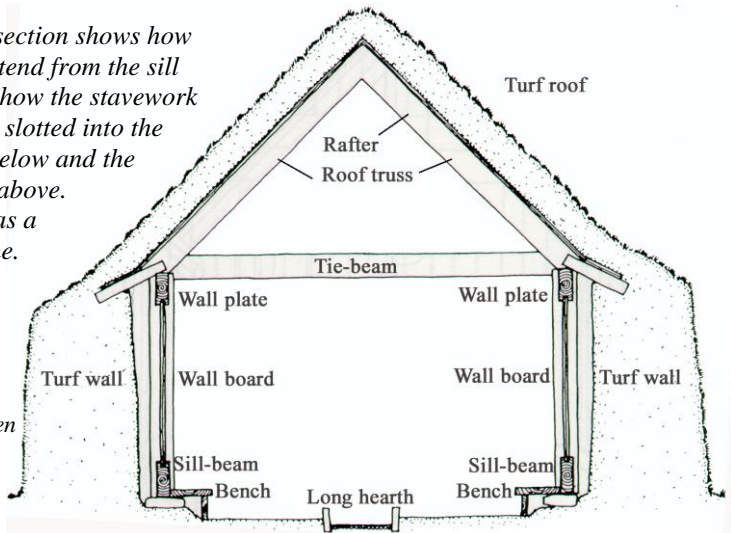
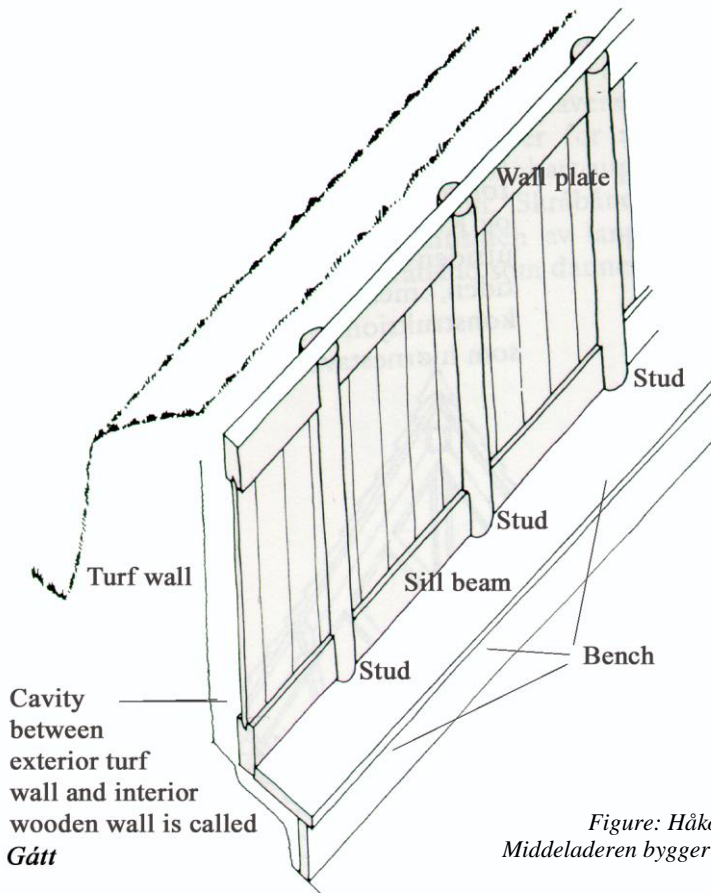
The cross-section shows how benches extend from the sill beam, and how the stave-work boards are slotted into the sill beam below and the wall-plate above. The roof has a rafter-frame.

Here we see the same form of stave construction. The boards stand vertically between the corner-posts, slotted into the sill-beam and wall-plate, which are tongued-and-grooved into the studs. This form of stave-work remained in use until about 1800.

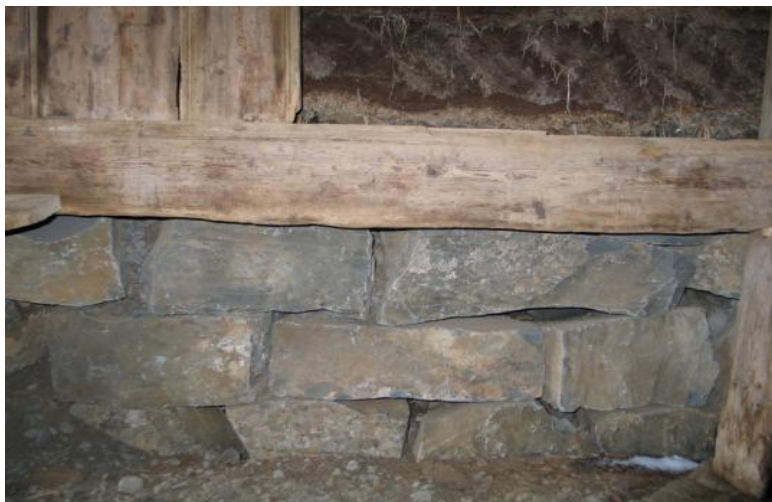
At the bottom of the wall at Reynistaður is a dry-stone base (þurrt grjót). Right: a corner-post stands on a foundation stone. The sill beam stands free of the ground. The ends of the wall boards are slotted into the beam.

At Reynistaður in Skagafjörður the entrance building to an old turf farmhouse survives, which dates from 1758-9. It is a fine example of the form of stave construction which was superseded in the 19th century by timber-frame construction. Both methods are seen here, as the boards of the end walls are of the timber-frame type (*slagbil* or vertical under-and-over boards. See page 2, 9, 24). Around 1830 Jón Samsonarson, who built Víðimýri Church in 1834, was commissioned to do some repairs at Reynistað-

ur, and the east wall may be his work. The western wall, on the other hand, is a modern replica based on the eastern wall, made in 1999. Two more buildings of stave construction are extant in Skagafjörður: the entrance building to the farmhouse at Stóru-Akrar, Blönduhlíð, and Gröf Church at Höfðaströnd, which dates back to the 17th century. At Stóru-Akrar part of a large turf farmhouse (*torfbær*), which was demolished in 1937, remains standing: the entrance building and passage include examples of 18th-century stavework. Alongside the entrance building is the former assembly hall for the Akrar rural district, a timber-frame building from the mid-nineteenth century. Both buildings have purlins (*langbönd*. See pages 11, 13) laid lengthwise across the rafters (*baksperrur*. See pages 7,11,12, 13), and the roof is clad in *reisifiöl* – boards laid across from ridge to wall. See page 13. *Skarsúð* is a different type of roof (See page 9). There the boards lie horizontally, overlapping (clinker-built). Both roofing methods were common. The timbers of the Akrar farmhouse provide evidence of how wood was used: some of the timbers of the house are older than the present building, and had clearly been reused from an older structure. At the period when stave buildings were being built in Iceland, and elsewhere in the Nordic region, another form of construction was equally common: the log house. Both forms of construction can be seen in the reconstructed Auðunn's House at Hólar.

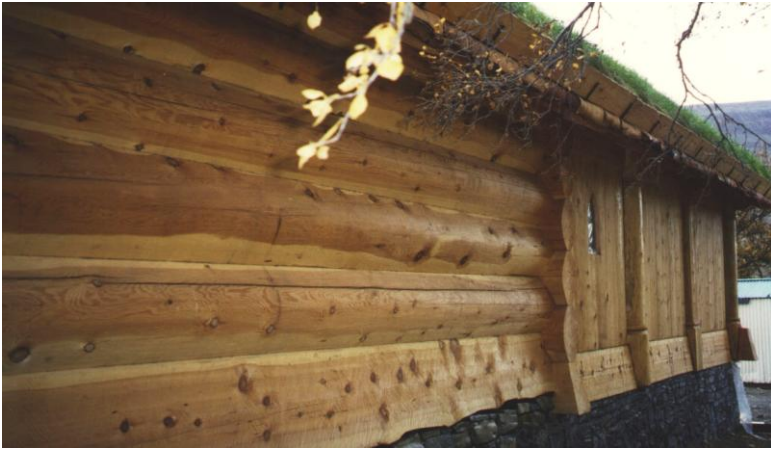
Auðunarstofa (Auðunn's House), a reconstruction of a lost building constructed for 14th-century Bishop Auðunn the Red, is built partly as a log house, and partly of stavework. The stavework section is farther away in this photo: wall boards stand upright between the corner-posts. At the front of the photo is the log-built wall, in which logs are placed horizontally to form the wall. Many variations of the two methods exist. Under the turf covering of the roof is a layer of birch bark.

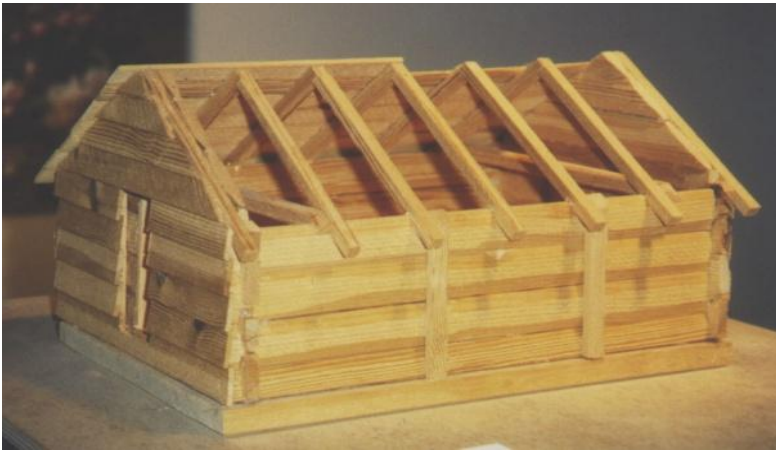
Model of log building, similar to the log-built section of Auðunarstofa (Auðunn's House). The model was displayed in the exhibition Stav og laft when the new Auðunarstofa was built 2002. The exhibition, from the Hardanger folkemuseum and Handverksregisteret in Maihaugen, explored the Norwegian-Icelandic architectural heritage.

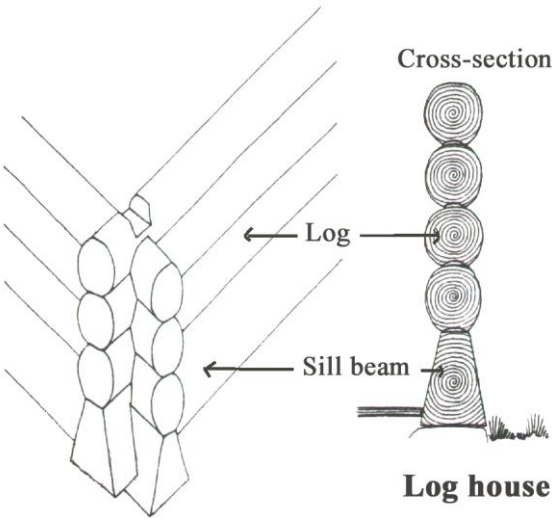
Log house

Examples include *Pakkhúsið* in Hofsó, a merchant's warehouse building from 1772/7, during the period of Danish trade monopoly (1602-1787). Buildings are constructed by placing the logs horizontally one atop the next, then notching them together at the corners to make a sturdy wall.

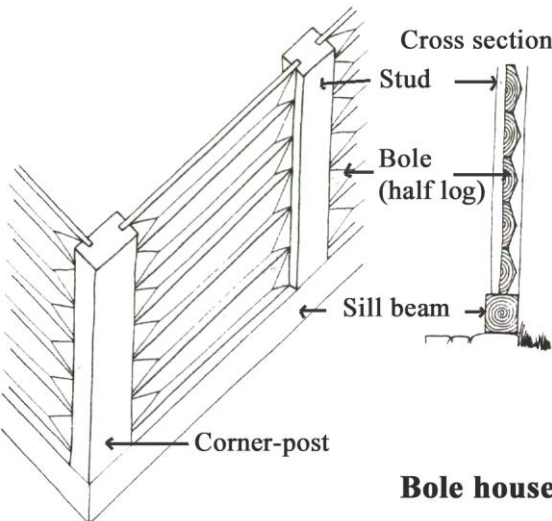
Bole house

In bole construction (*bolverk*), boles (half-logs) are slotted into corner-posts (see diagram). When the wall reaches the desired height, rafters and tie-beams are fixed on top of them. The accurate assembly of the logs is vital.

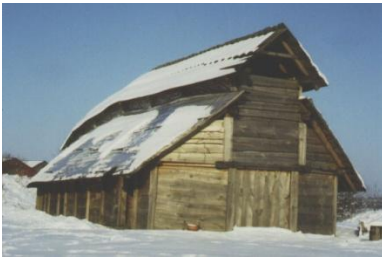
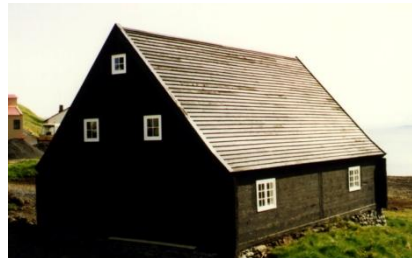
Left. Viking longhouse at Hage, Sweden, built as an example of a log house of the old Nordic type. Right. Pakkhúsið, Hofsfós (18th century). The roof is clinker-built (skarsúð): boards lie lengthways, on purlins, overlapping so that there is little risk of leakage.

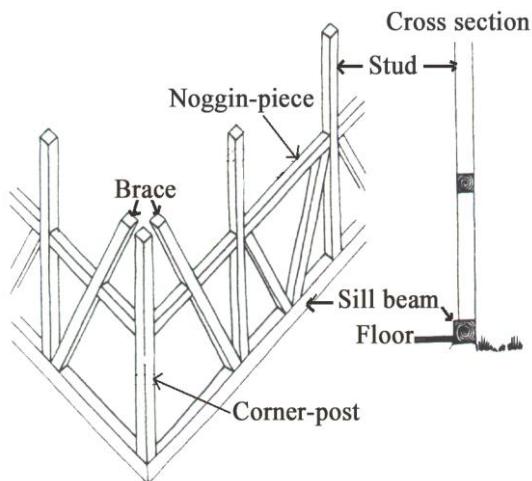
Timber-frame method (bindingsverk)

As in stave construction, a timber-frame building has vertical posts (studs), which are more closely spaced than in stavework. Whereas in stavework the wall-boards serve to brace the frame, in timber-frame construction the frame itself is rigid, and is clad inside and out. The timber-frame method was brought to Iceland and Norway via Denmark, from Germany and Britain.

In timber-frame buildings the frame construction is clad inside and out.

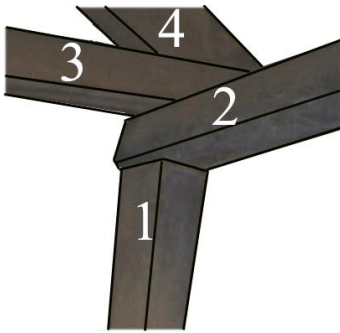
The figure shows the joinery between the wall frame and roofing timbers in Litlabúr (the Small Pantry) in the Glaumbær farmhouse. 1) stud, 2) wall-plate, 3) beam, 4) rafter. Studs are fixed by mortise-and-tenon to the wall-plate: a hole (mortise) is cut into the wall-plate, corresponding to a peg (tenon) cut from the end of the stud. The beam which spans the pantry is fixed by mortise-and-tenon into the top of the wall-plate, and the rafter is fitted into a slot in the top of the beam. The studs stand on foundation-stones. The building is not panelled.

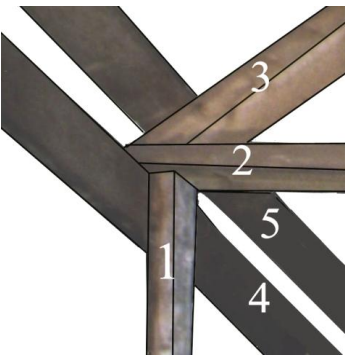
The open-hearth kitchen at Glaumbær has a different example: 1) stud, 2) beam 3) rafter. These are fixed together by mortise-and-tenon and nailed. 4) The wall-plate is slotted onto the stud. The beam rests on top of it, extending beyond the wall-plate. 5) The bottom purlin is nailed to the rafter. Like the Small Pantry, the kitchen is unpanelled.

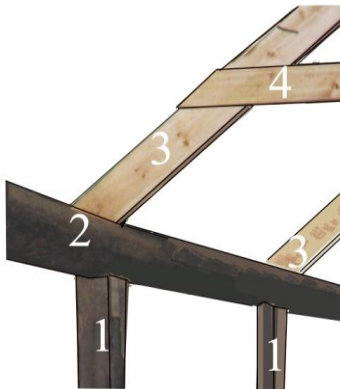
The beam sometimes does not rest on the wall-plate, but is fixed by mortise-and-tenon to the rafter (see figure). It is then termed a tie-beam (skammbiti). The figure shows part of the framework of the North Pantry. 1) stud, 2) wall-plate 3) rafter, 4) tie beam. The rafter is fixed by mortise-and-tenon to the top of the wall-plate. In some cases a socket was cut from the tie-beam, and the joint was pierced and fixed with a wooden peg or treenail. This is a more

secure type of joint. The building is unpanelled, except the end wall opposite the door, which has a panel with plate-rack and attached table.

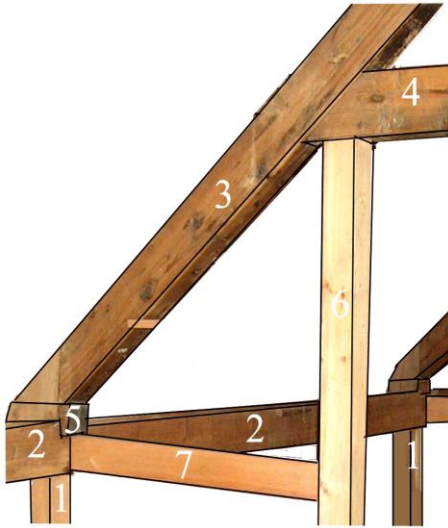
The frame of the baðstofa (communal living loft) of Glaumbær shows a fourth variant: 1) studs, 2) wall plate, 3) rafter, 4) tie beam, 5) false beam end, 6) post, 7) strut. All the joints are fixed together by mortise-and-tenon. The tie-beam is pegged into the rafter. The studs are fixed at the bottom by mortise-and-tenon into the sill beam, which stands on stones. The entire building is panelled.

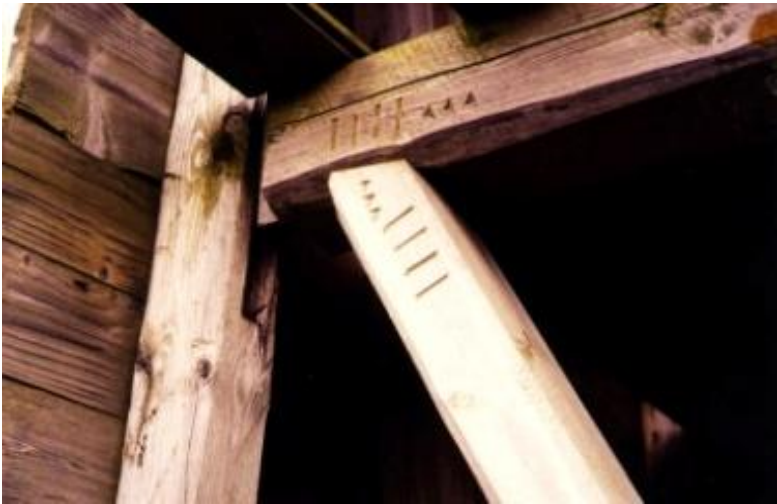
Timber frame of a building at Unastaðir, Kolbeinsdalur. The building was prefabricated in Norway around 1930, and the timbers brought to Iceland ready for assembly. The beam is fixed by mortise-and-tenon into a stud, and a brace slotted into the beam. The exterior is timber-clad, while interior panelling has been removed.

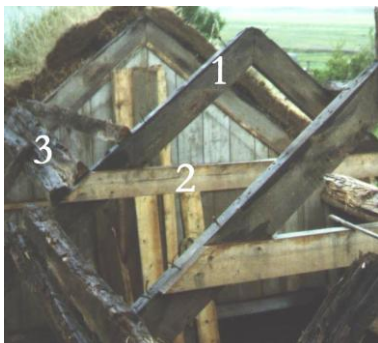
Left. 1 Roof truss, pair of sperrur (rafters). 2 Tie beam. 3 Fragments of wood.

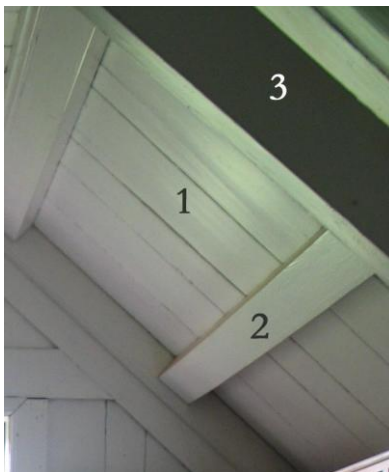
Right. 1 Roof clad with boards laid across from ridge to wall (reisifiöl). 2 Purlin. 3 Part of raft (sperra).

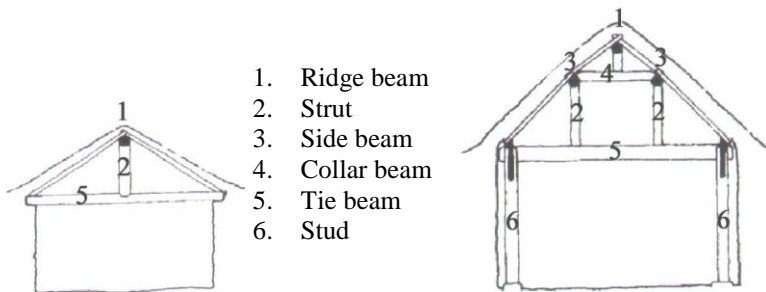
Ridge-beam roofs: Single-beam and triple-beam.

1. Ridge beam
2. Strut
3. Side beam
4. Collar beam
5. Tie beam
6. Stud

Left. Tie-beams are laid across between the walls. Atop the beam is a strut, beneath the ridge beam. Rafters were laid from the ridge-beam across to the walls. Small slabs of rock were often placed on top of the walls, under the rafters and beam-ends.

Right. A more complex structure is the triple-beam roof, in which the tie-beams are fixed to studs by mortise-and-tenon. On top of the tie-beam are struts. Árefti is laid between the ridge-beams and the wall-plate.

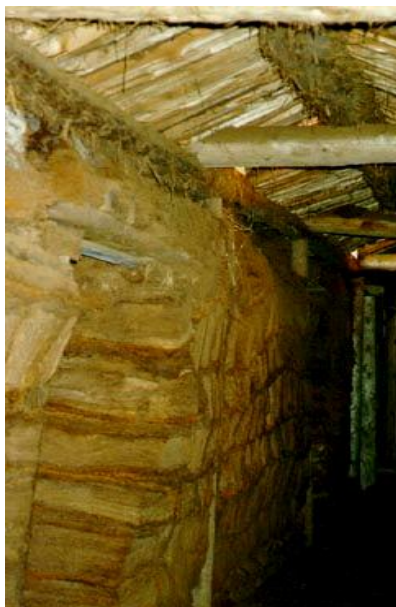
Single-beam roof with post under the ridge

The photo shows a single-beam roof and turf wall in a passage of the Glaumbær turf farmhouse. The wall-plate is on a timber piece that lies on the wall. Atop it are collar beams (vaglar) which support the ridge-beam. Because the passage is narrow, the weight can rest on the walls. Good building rock is scarce on the Glaumbær estate, but the land offered (and still offers) excellent building turf (torfrista). This probably explains why there is so little rock in the walls at Glaumbær. The same rocks were re-used over and over again. Some of the rocks visible in the walls have probably been used repeatedly over the centuries. When turf walls were demolished the rocks were reclaimed for re-use, while the old, degraded (uppmýldað) turf was broken up and disposed of, unless it was usable for filling in new walls.

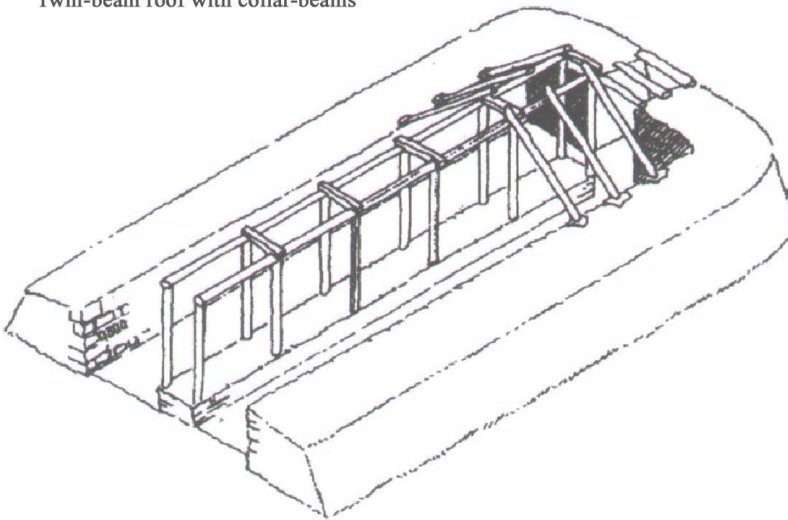
Triple-beam roof with collar-beams and struts beneath the ridge beam

These two buildings differ in that the upper – which could be a hay-barn – has posts supporting the ridge-beam. Rafters lie from the beam out to the walls. The lower building is broader, a sheepshed with a twin-beam roof. Pairs of posts support the two roof-beams, with collar beams between them. Rafters lie from the roof-beams out to the walls, as in the single-beam structure. The figure shows how beams were laid across the top of the doorway in the turf walls.

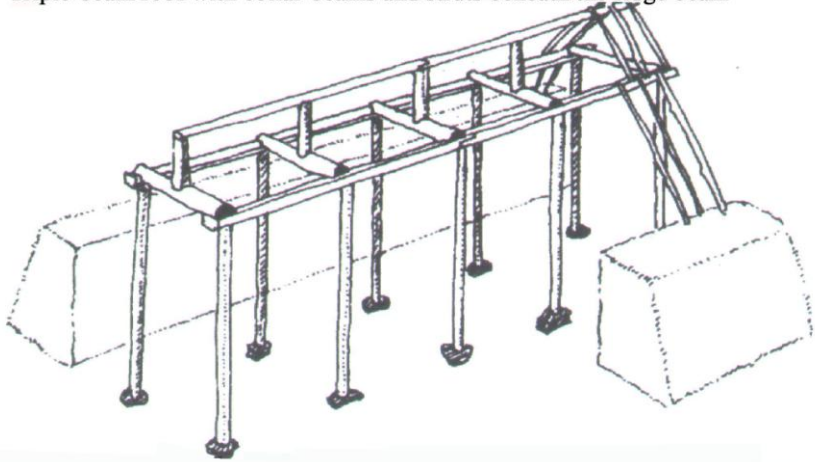
The figure shows a triple-beam roof of the same type as in the photograph below.

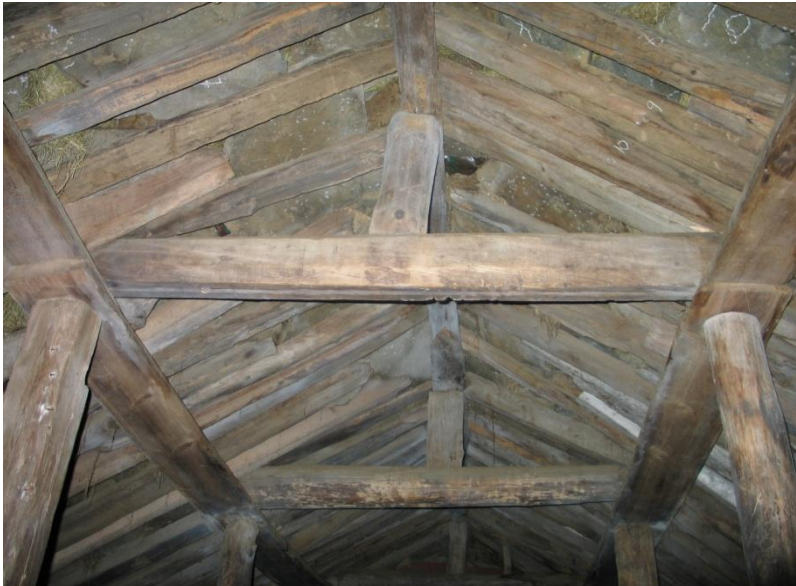
Triple-beam roof of a hay-barn at Núpsstaður, in Skaftafellssýsla. The roof is as shown in the figure above. Struts stand on collar beams under the ridge-beam. The two side-beams rest on posts.

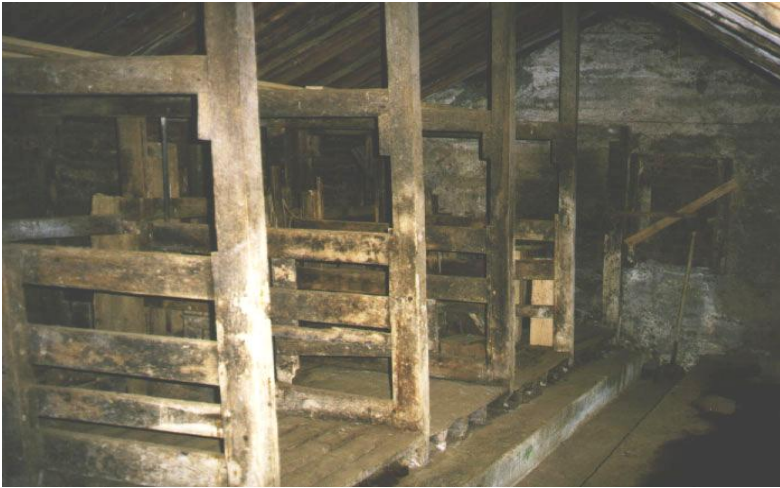
The cattleshed at Bustarfell in Vopnaffjörður has a single-beam roof. The spacing of the posts under the ridge beam determines the width of the stall for each animal. The spacing of the posts is a function of the weight-bearing capacity of the timber. A roof covered with stone slabs and an outer layer of turf is heavy. The dung gutter is located behind the stalls.

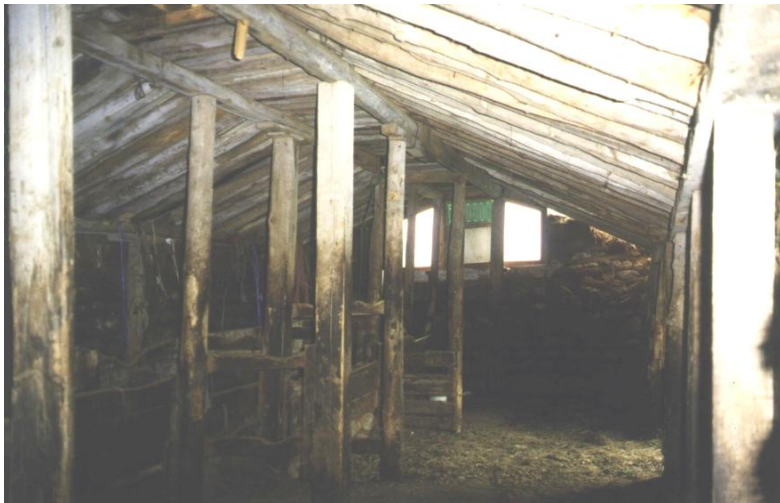
Cattleshed with twin-beam roof at Syðri-Hofdalir, last used as a stable. The roof beams and wall-plates rest on posts. Rafters lie between walls (wall-plates) and roof-beams. The posts beneath the beams correspond to the interval between stalls.

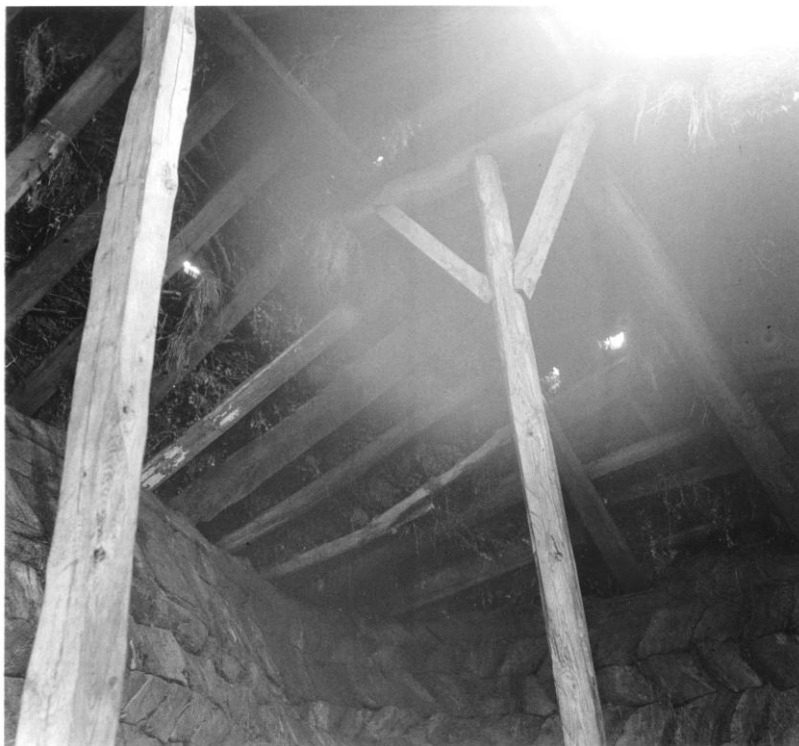
Post of twin-beam roof of a hay-barn. The posts stand under collar beams, which are reinforced by diagonal braces, and support the roof-beams. Rafters lie from the walls to the beams. Under the rafter ends, atop the walls, are small slabs of rock. In this building the rafters are densely-spaced, and turf can be laid directly on top of them. If rafters were more widely spaced, a layer of árefiti had to be laid across the rafters, as an underlayer for the turf roof: árefiti often comprised odd bits of wood, not useful for any other purpose. The walls of the barn are built of turf, using wedge-shaped klömbruhnaus with intermediate layers of strengur (strips of turf tapering to one side). The underside of the turf roof is visible between the rafters. Árefiti was often timber which had been used and re-used many times in building frames, and had reached the end of its useful life. On occasion, timbers have been found in roofing which once graced the homes of chieftains, hundreds of years ago. Such fragments may have mouldings, holes for pegs or treenails, and even ornamental carving.

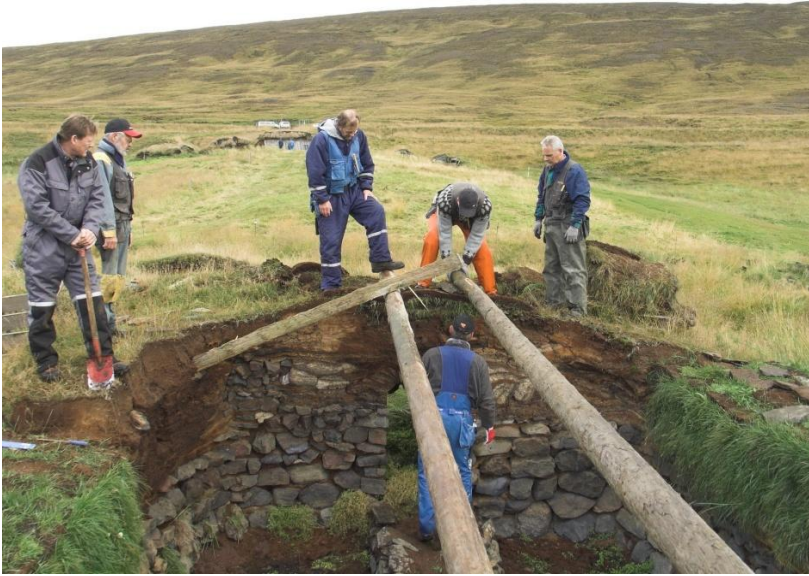
Tyrfingsstaðir. Twin-beam roof: the beams have been laid, and the first rafter is being put in place. The rafter lies on a small slab atop the wall.

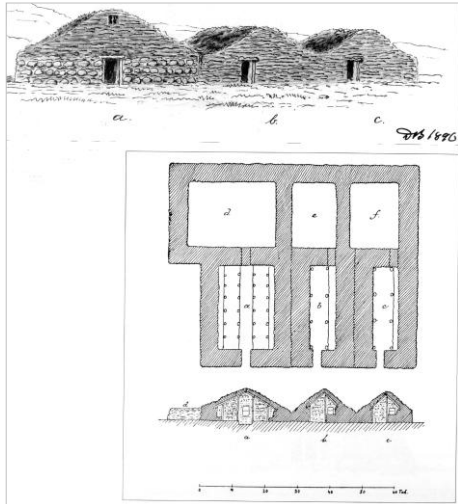
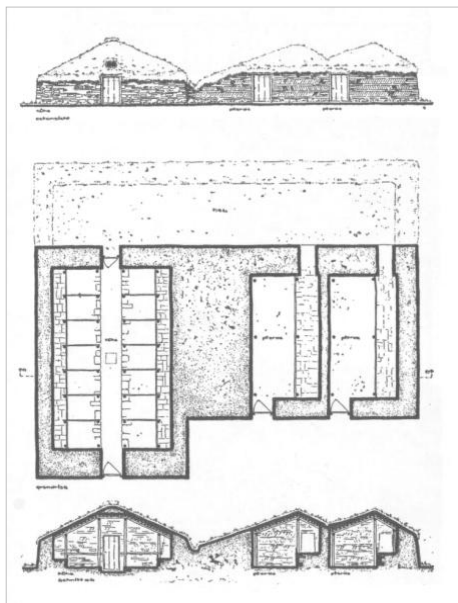
The upper drawing by Daniel Bruun (1896) shows a cattleshed and two stables at Glaumbær (nos. 2 and 3 in the figure on the previous page). The drawing indicates that the cattleshed was built of rock and turf, while the walls of the stables appear to be more turf than stone. The stables had single-beam roofs, with four pairs of posts. The cattleshed had a twin-beam roof, with eight pairs of posts on either side. Haybarns were located behind the buildings. The lower drawing shows the same buildings in 1936. The cattleshed has, as before, 14 stalls, with mangers at the outer wall and dung-gutter in the middle. The stables had been reduced in length by one pair of posts. The hay-barns had been removed, and behind the buildings was a rick yard

where hay was stored in stacks or ricks, which were protected by a layer of turf. This method superseded the hay-barns of the 19th century. Drawing E. Sacher, 1936.

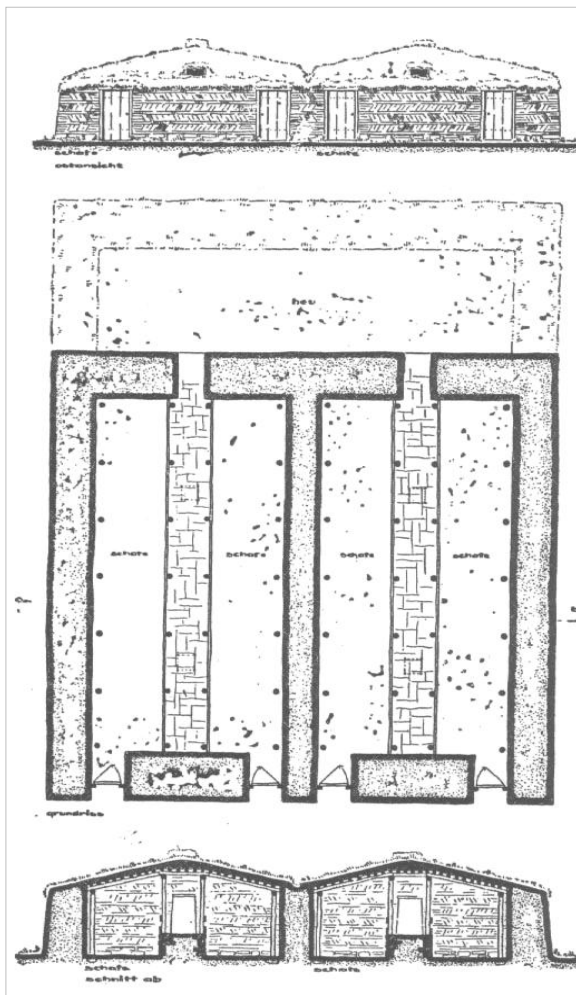
The drawing shows a pair of sheepsheds of the *garðahús* type (i.e. with sheep on both sides, and manger (*garði*) in the middle). The sheepshed stood low down in the *Glaumbær* home-field until 1940. This is building no. 4 in the drawing of *Glaumbær* in 1936 (page 19). No trace of these buildings remains today. The buildings stood by the brook (ditch) in the old homefield, near where the oldest traces of habitation at *Glaumbær* have been found. As the figure shows, the building comprised two sheepsheds, each

with two sheep pens. Each pen took about 50 sheep. Down the middle of each shed was a manger, and each pen had a separate entrance. These sheepsheds were built mostly of turf, with rocks in the bottom layers. Drawing E. Sacher, 1936.

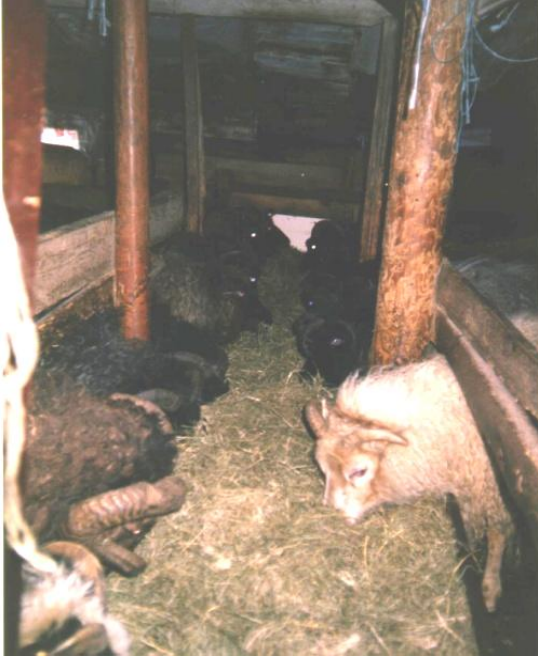
Photo from a shed of the same type, with a central manger built of rock. The posts rest on the stone manger, under twin roof-beams. This is a double-sided garðastokkur. In general the central manger was built of rock, and the roof posts rested on top of it. This saved valuable timber, as the posts could be shorter. The interval between the posts determines the width of the manger. A wooden garðastokkur (base) and garðabönd (horizontal

wooden bars) were nailed to the posts. By inserting their heads through the gaps, the sheep could reach the hay placed on the manger for them.

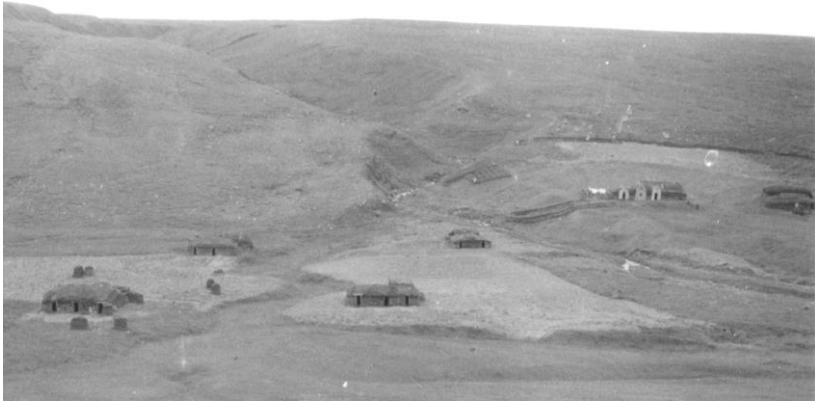
Steiná in Svartárdalur around 1935. Taken at haymaking time, the photo shows how buildings were widely dispersed. Laundry has been hung out to dry outside the farmhouse. To the right of the farmhouse are livestock sheds, and to the left is the driveway. Paths lead from the driveway across the brook, and along the hillside above the grassfield, to the left. In the gully by the grass-field wall is a large potato patch. In the grass field are four livestock sheds, probably sheepsheds. Around the buildings at the far left are stacks of dung, gathered from the sheepsheds and dried to use as fuel in the open-hearth kitchen

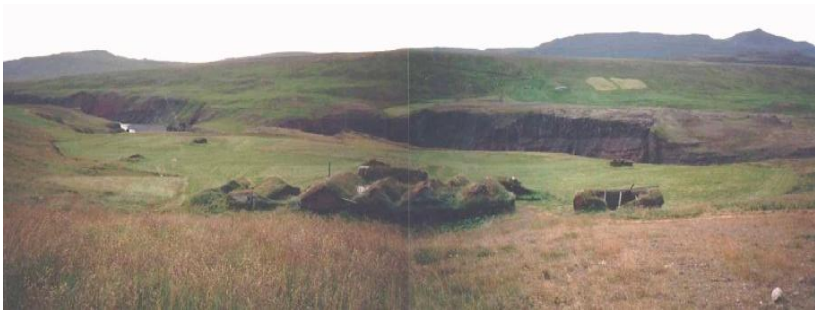
Tyrfingsstaðir, Kjalvík, 1991. The farmstead buildings form a cluster of six. Down in the grassfield, in the background of the photo, are sheepsheds, well-spaced-out.

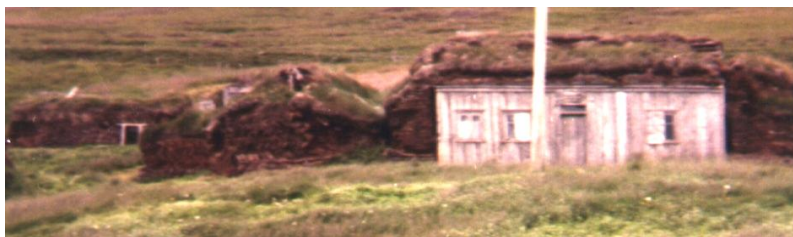
Tyrfingsstaðir around 1960. The wooden wall which faces forwards is part of the front building (framhús) of the farmhouse. The front building led to the passage, which gave access to the back houses, and thence to the lamb-house and cattleshed, which lie to the left of the farmhouse. At the rear is the cattleshed barn. The farmhouse was inhabited until 1969. The buildings vary in age. The pantry and open-hearth kitchen date from 1860 in their present form. The baðstofa (communal living loft) was built around 1890, and the framhús (front building) in 1904. Photo Egill Helgason.

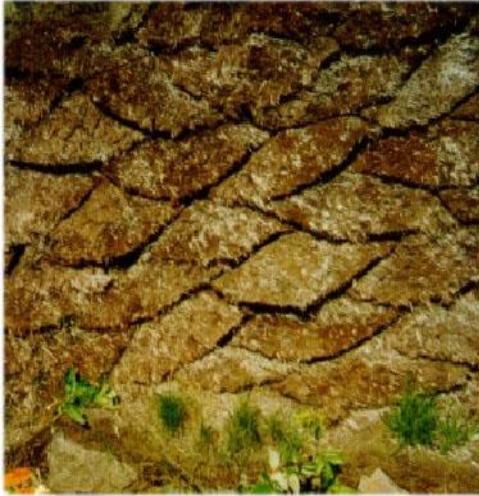
Turf blocks (*hnaus*, cut with a turf-spade) for building can be cut in many different shapes. *Snidda* is a diamond-shaped block; *kantsnidda* or edging *snidda* (see photo) was used for edges, as it was conducive to the vegetation recovering quickly. The roots are deep, and the wall bonds together rapidly due to the vegetation. In this case, the wall has been scorched by the sun.

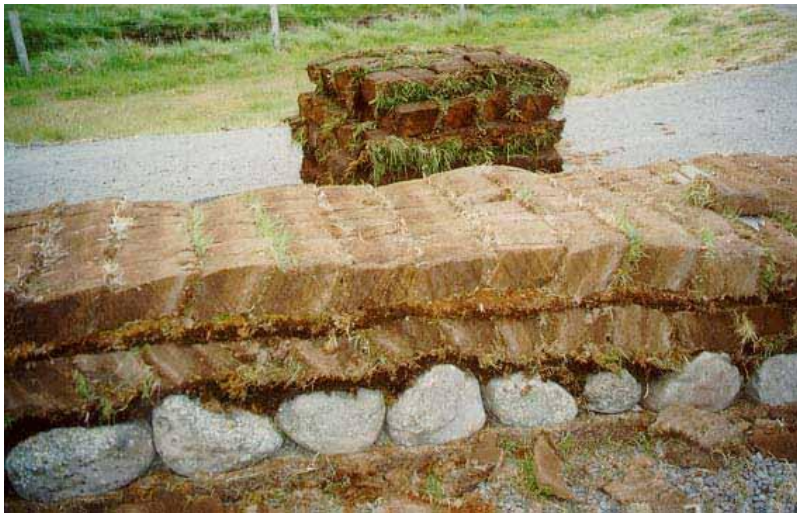
The photo shows hnaus (turf blocks) laid crosswise to build a wall. The resulting herringbone pattern is similar to that of a wall built of wedge-shaped klambra, with the thick end of the wedges forming the face of the wall. This form of hnaus is known as Glaumbær hnaus, as it is unique to the Glaumbær building. A wall of this kind requires little filling, and that makes for a more robust and stable wall.

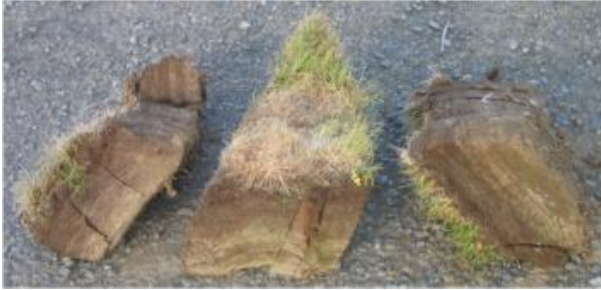
Wedge-shaped klömbruhnaus turf pieces.

The turf wedge is placed in the wall with the thin end inwards and the thick end outwards.

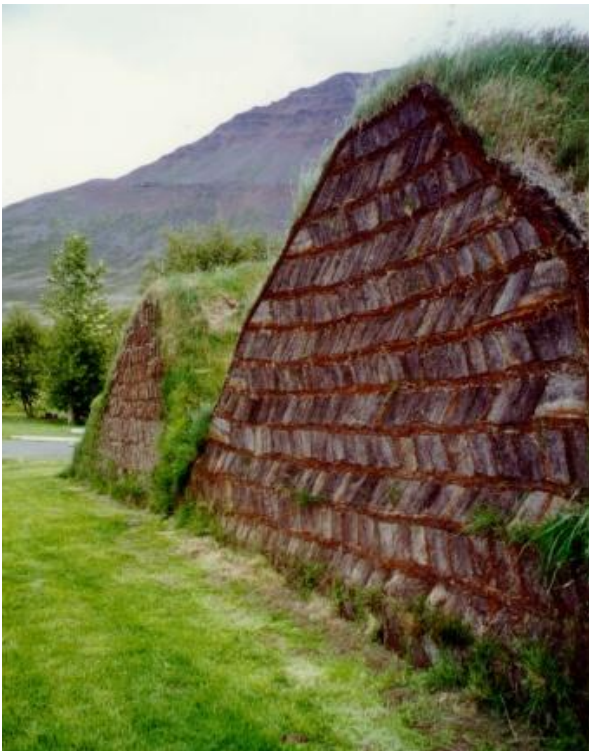
Gable walls of Nýi-Bær at Hólar, built of klömbruhnaus.

In constructing walls for buildings, it was important to ensure that the turf was partially dry, so that it would not subside too much, and would not be too damp. In cutting turf, and trimming it into shape in the wall, it was important to keep the tools (scythe, spade, etc.) sharp.

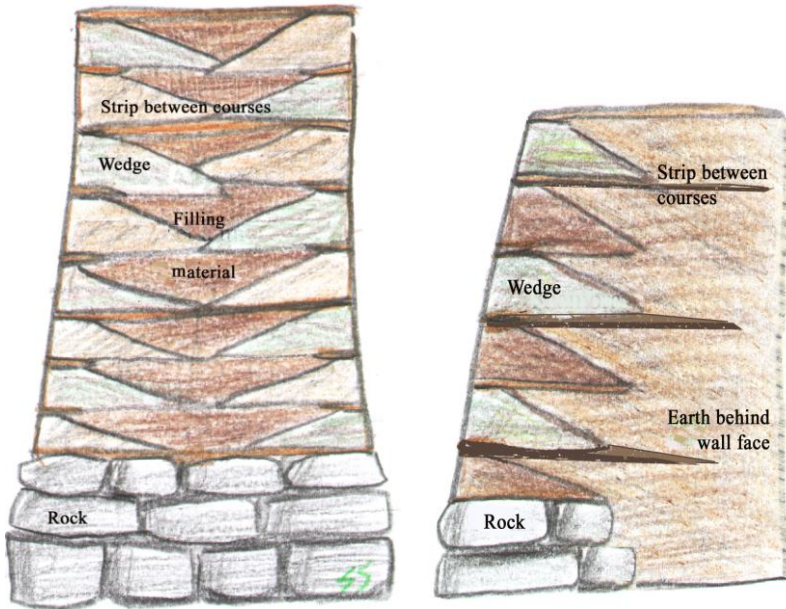
The figures show a double-faced and a single-faced wall structure. A double-faced wall, for instance for a house, is built the same on both sides. A single-faced wall is backed with earth and filling materials. Edges are generally built of snidda turves, rather than klambra/klömbruhnaus.

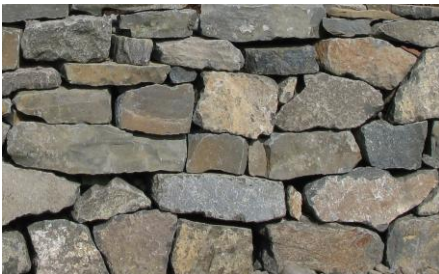
Drystone wall of natural uncut rocks without mortar or turf.

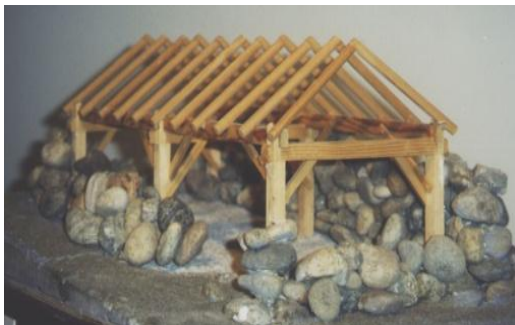
The simplest berms were made by piling up rocks around a wooden framework (for instance for fishermen's simple shacks), and then covering the whole structure in turf. The photo is of a Norwegian model of such a structure in the exhibition Stav og laft.

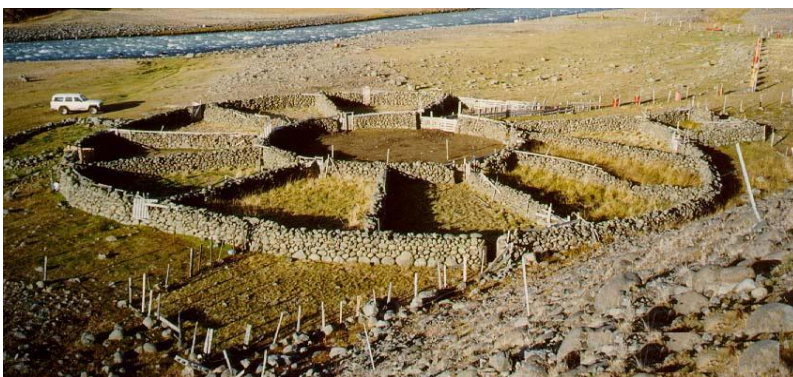
Sheep corral at Bjarnastaðahlíð, Vesturdalur (used during the round-up in autumn, when sheep are herded down from mountain pastures). The corral is built of natural rocks gathered from the river-spits around.

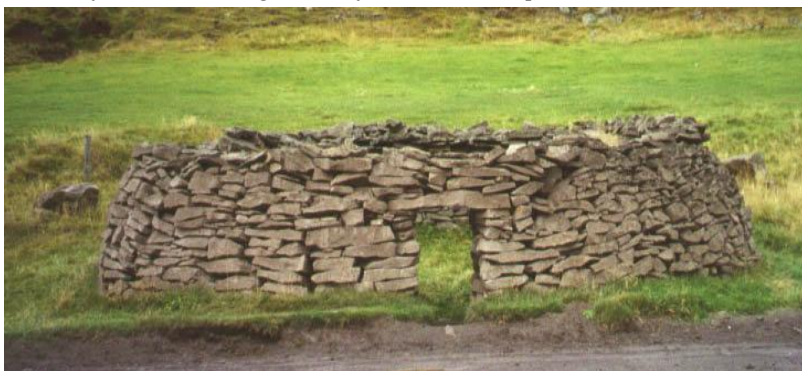
At Litli-Bær, Skötufförður, is a sheep pen built of rock from the scree on the nearby mountain – mostly flat rocks.

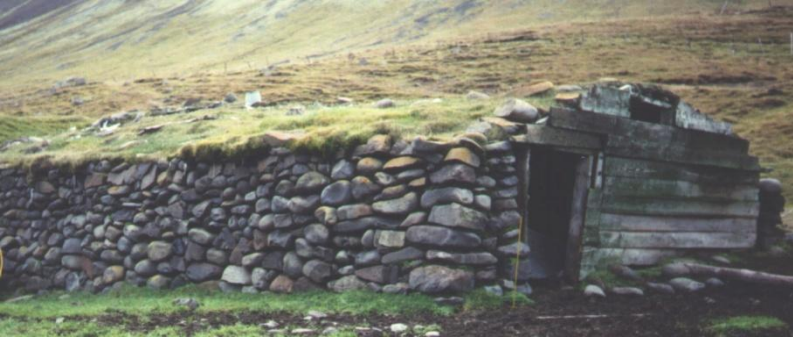
This sheepshed at Skatastaðir is built of scree rock, with strengur turf strips (in the wall). The shed has a manger along one of the long walls. Shallow-pitched pairs of rafters rested on flat rocks atop the walls.

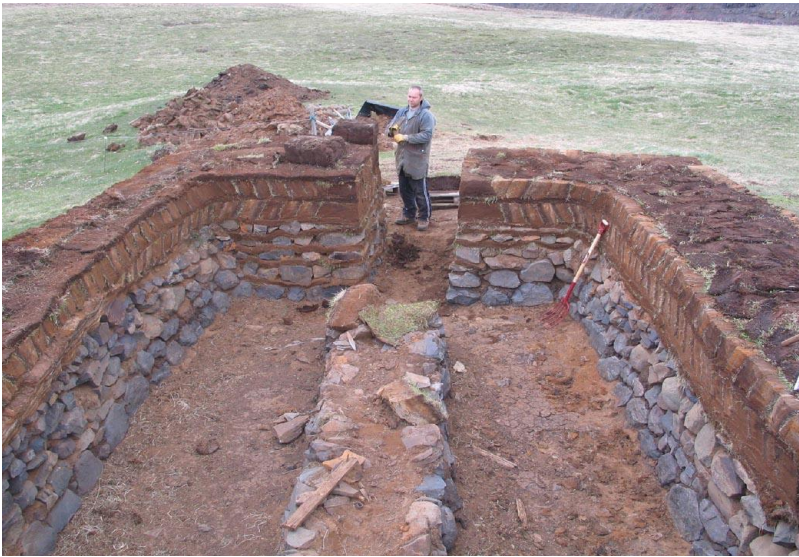
View down into a sheepshed comprising two pens, with a rock manger base between them. Posts supporting the roof beams rested on the rock base. In most livestock sheds in north Iceland from olden times, the walls comprise rock and turf at the bottom, while the upper section of the wall is turf alone.

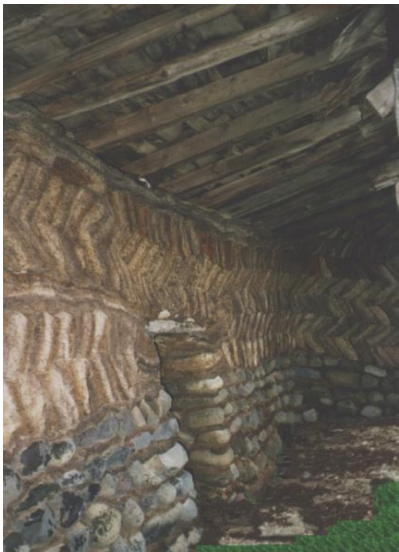
A common method of making doorways was to lay beams of wood across the entrance, and then build up the turf wall above it. Photo: barn at Bakkakot in Vesturdalur which illustrates such a doorway. A beam is laid on top of the wall, under the ends of the rafters. The rafters are first covered with árefti, then turfed.

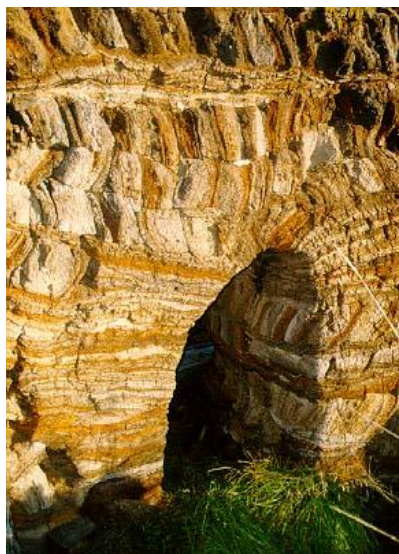
Arched doorways were a common feature. These were formed by extending the layers of turves from either side to meet in the middle. Photo from the farm Flatatunga.

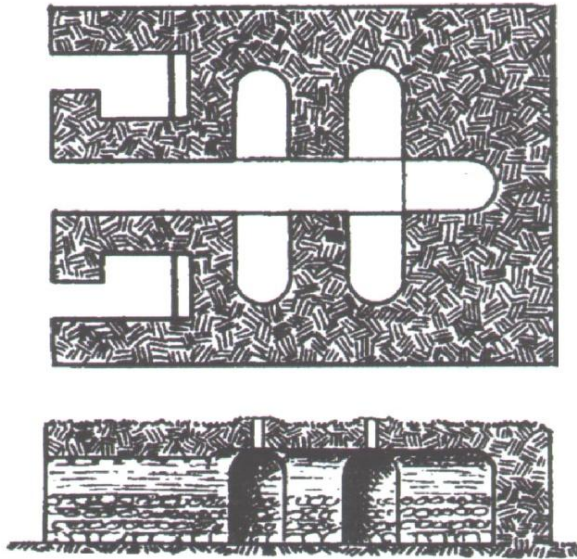
Samhlaðið fjós

Small buildings were sometimes built with a roof of turf alone, without any timber frame or roof members (samhlaðin). The turf walls were built curving upwards to form a rounded roof. The upper figure shows a krosshlaðið (cruciform) cattleshed with five stalls, together with two stables.

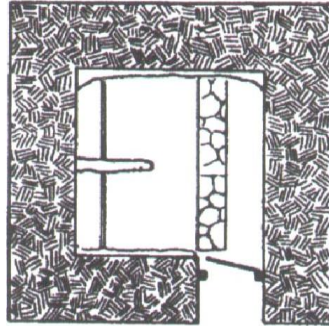
This cattleshed has a low manger base built of rock. The stalls are divided by a slab of rock. The dung gutter is paved with slabs. The walls are reinforced with rocks at the base, and a roof vent provides ventilation. Drawings from Hörður Ágústsson: Íslensk byggingararfleifð. Ágrip af húsaerðarsögu 1750-1940.
